№ GJW2019-5062

TEST REPORT

NAME OF SAMPLE : record STA20 IP65, RED/DUO incl. VRR20, BAT16 and FEM0

CLASSIFICATION OF TEST : Commission Test

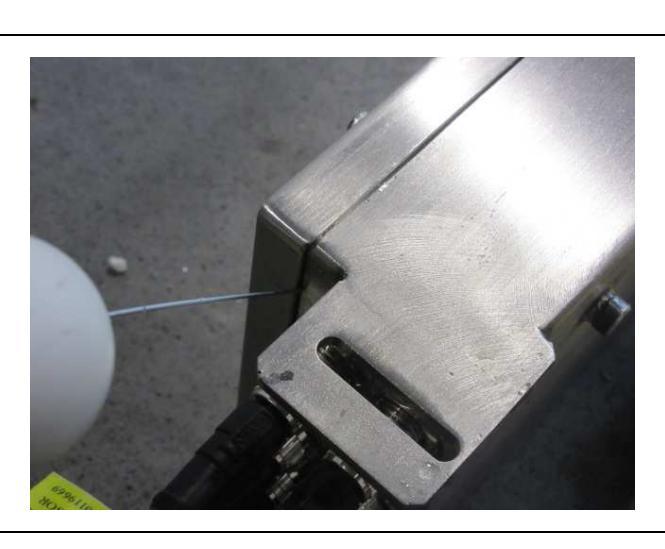
Fig 2: The object probe of 1mm Φ does not penetrate the enclosure of the sample.

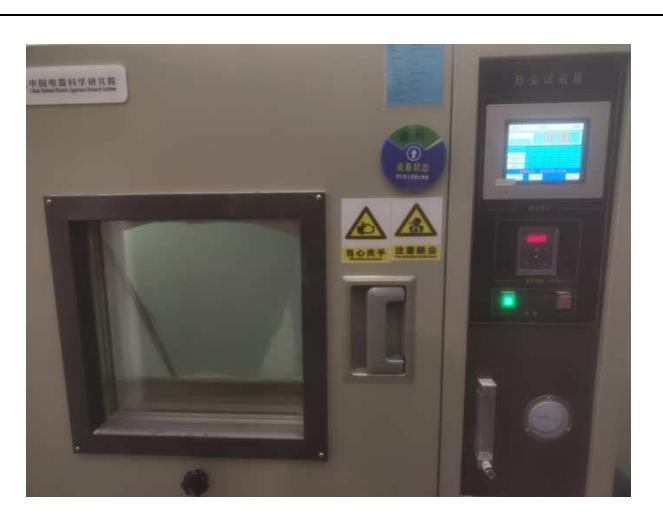
Fig 3: IP6X testing

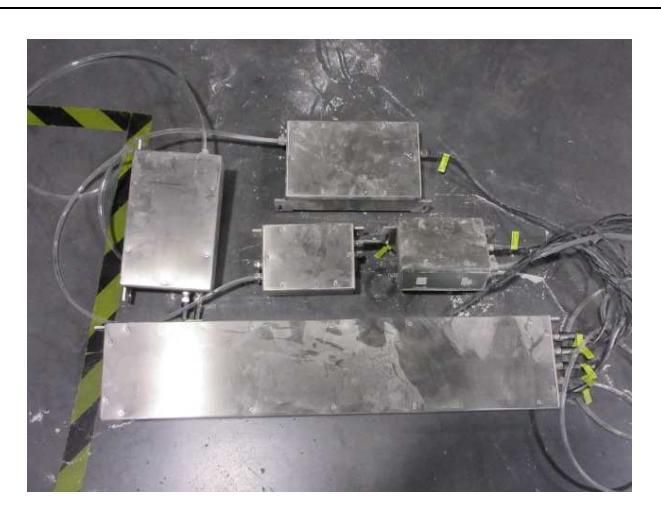
Fig 4: After IP6X test

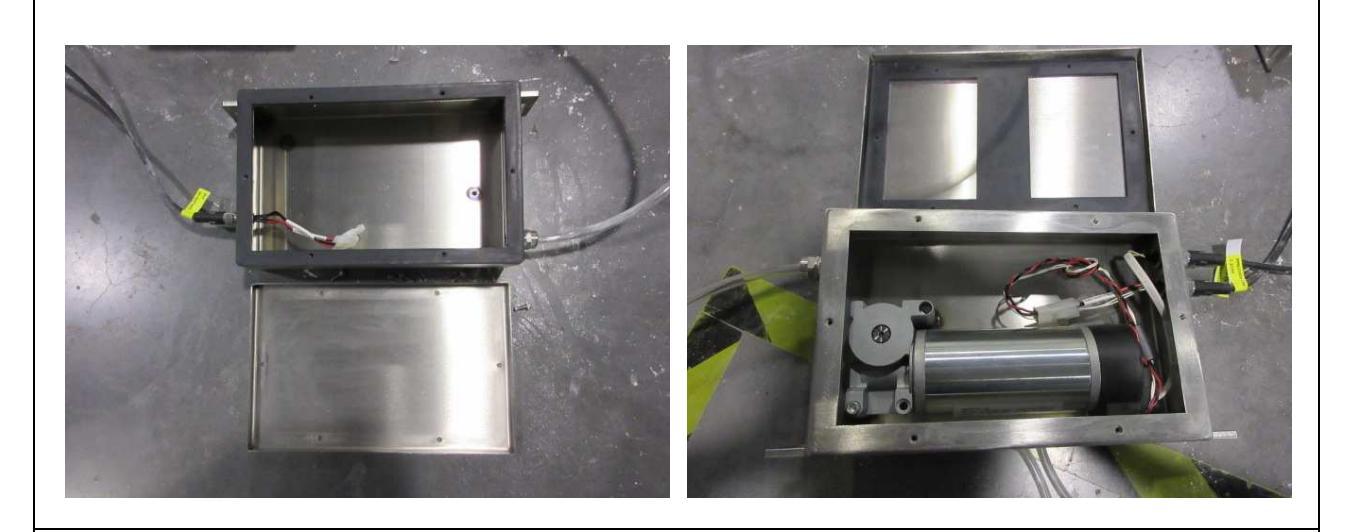
Fig 5: After IP6X test, no dust is visible in the enclosure of the sample

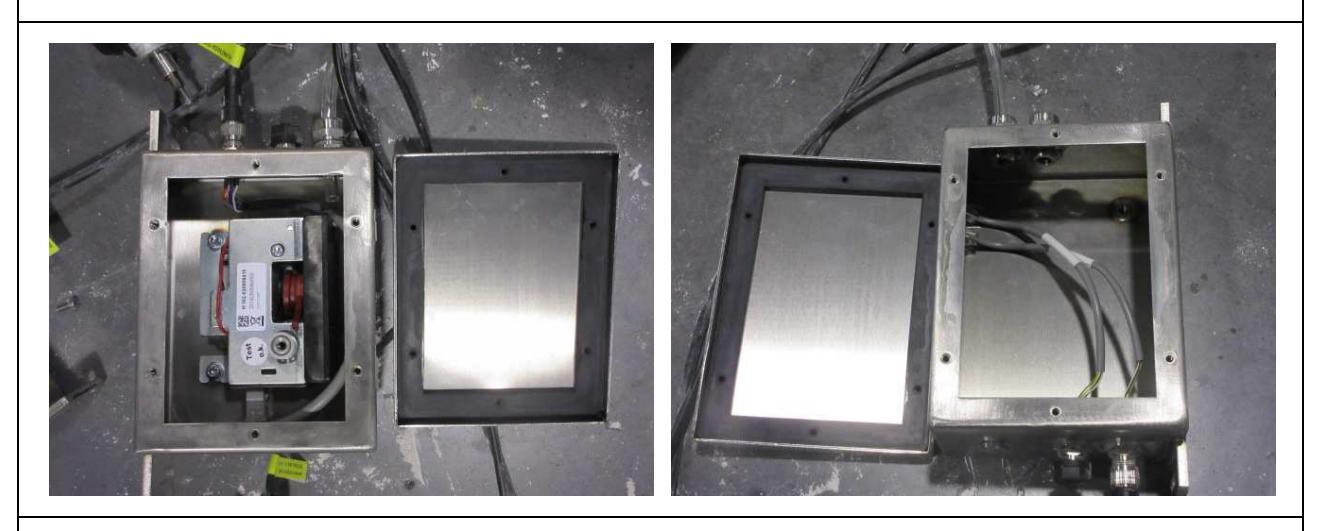
Fig 6: After IP6X test, no dust is visible in the enclosure of the sample

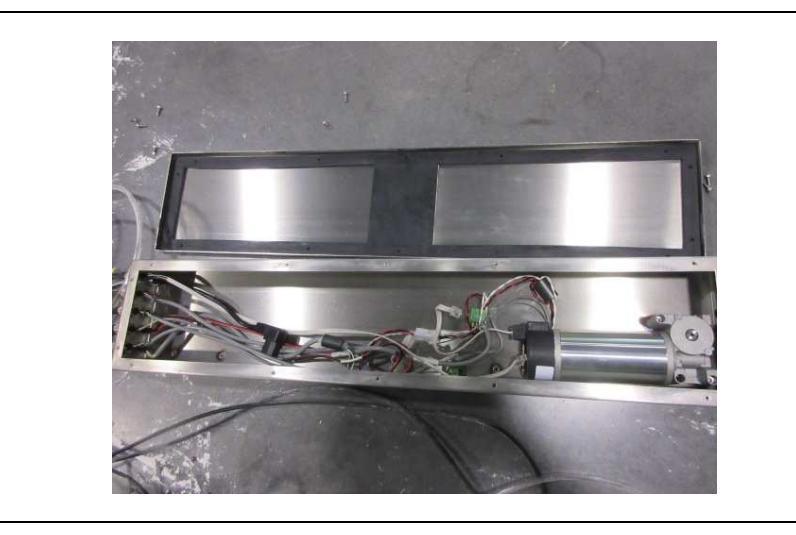
Fig 7: After IP6X test, no dust is visible in the enclosure of the sample

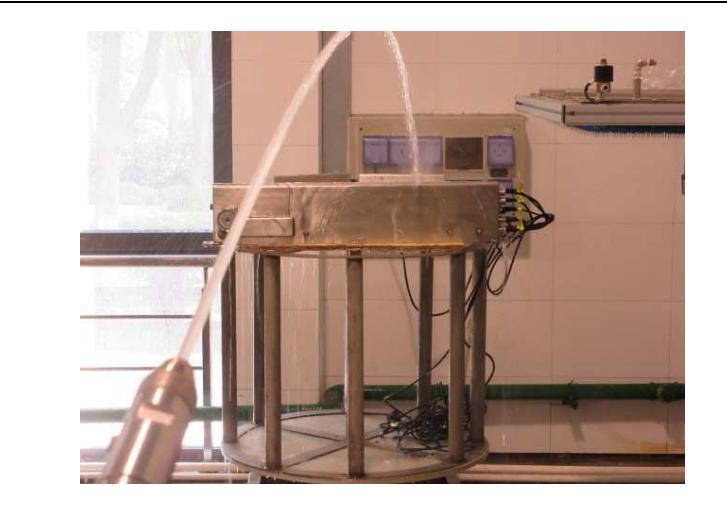
Fig 8: IPX6 testing

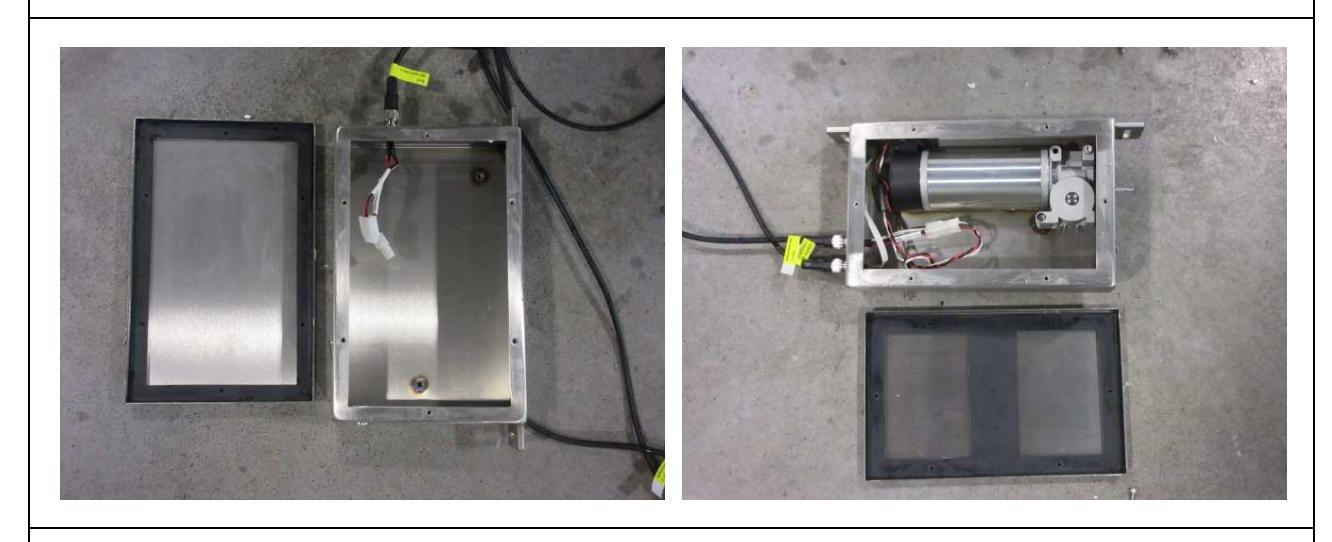
Fig 9: After IPX6 test, no water is visible in the enclosure of the sample

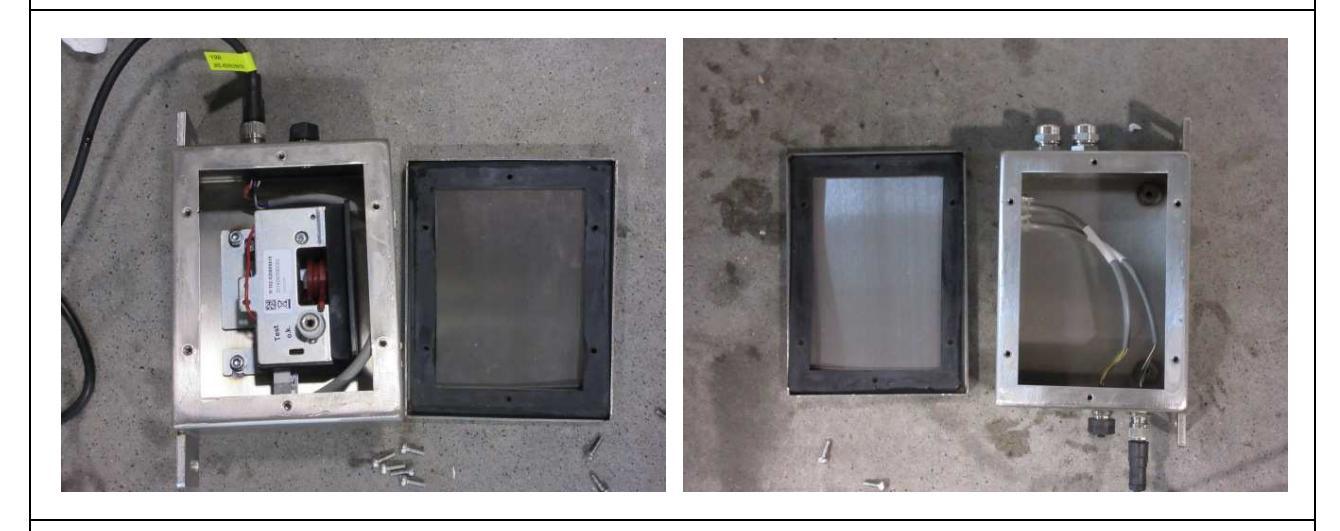
Fig 10: After IPX6 test, no water is visible in the enclosure of the sample
